THE UNITED STATES DISTRICT COURT FOR THE SOUTHERN DISCTRICT OF GEORGIA STATEBORO DIVISION

EXPERT REPORT OF John M. Paquet, P.E. June 4, 2015

Introduction

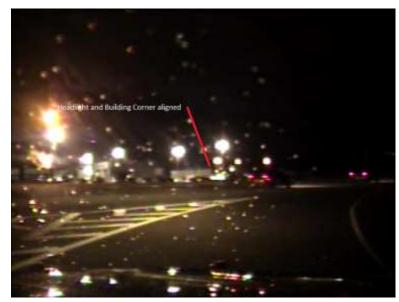
Figure 2: Frame capture from Dash Cam Video, at approximately 49.38 second point

3.17. The headlights of the southbound vehicle consistent with Ms. Brown's 1992 Honda can be seen to pass in front of the southeast corner of the Franklin Chevrolet Collision Center building at approximately 49.38 seconds into the video.

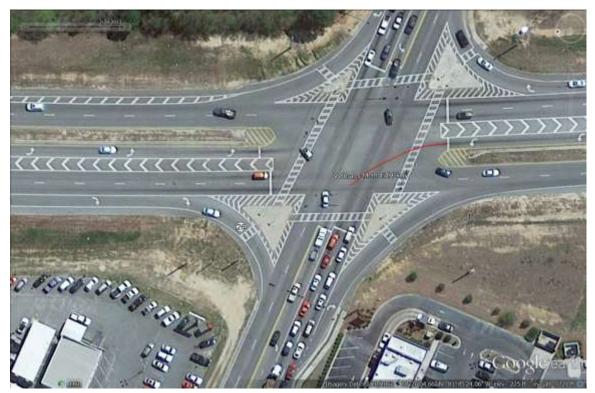
Figure 7: Google Earth aerial image showing curved travel path from stop bar to area of impact, a distance of approximately 107 feet along the arc path

- 14.7. Assuming a curving path from the stop bar in the northbound left turn lane to the area of impact in the right southbound lane, as shown in Figure 7 below, the travel distance from the stop bar to the area of impact for the International truck driven by Mr. Krull was approximately 105 to 110 feet.
